PROJECT APPLICATION FORM – 2016

Applicant:	South Acton Congregational Church	<u>Submis</u>	sion Date: Nov 19, 2015
Applicant's Address:		Purpose: (Please select all that apply)	
35 School S	Street	0	Open Space
Acton, MA 01720		0	Community Housing
Phone Number: 978-263-2332		X	Historic Preservation
E-mail: info@southactoncc.org		0	Recreation
Town Comm	nittee (if applicable):		
Project Nam	ne: South Acton Congregational Chur	ch Roof Repa	ir (Historic District Church)
Project Loca	ation/Address: 35 School Street, Act	on, MA 0172	0
Amount Req	<u>uested: \$15,000.00</u>		
Project Sum	mary. In the chace below provide a brief	f cummary of t	he project

Scope of Work:

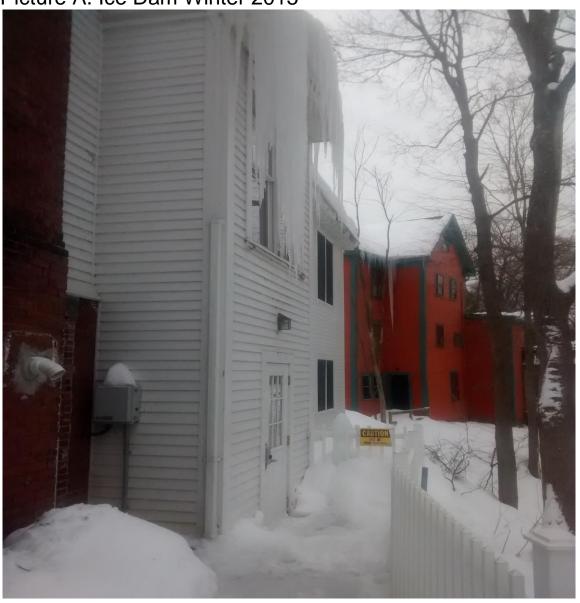
Picture A. Ice Dam Winter 2015

The purpose of this project is to perform roof repairs to prevent ice dam formation (See picture A, Ice Dam Winter 2015) to preserve an historic structure. Absent this fix, ice dams will continue to form each winter resulting water backing up into the roof and leaking into the building, damaging the ceilings, walls, and eventually rotting the structure. Increased use of the building by the community extends the periods the building is heated to room temperature. This increases the heat loss and melting of roof snow, aggravating the longstanding ice dam problem. These ice dams and the resulting intrusion of melting water has already resulted in the damage to the building. We have already replaced some of the sill beam and more needs to be replaced. (See picture A, Rot on Sill & Cover Due to Water Dripping Off Ice Dam.) There has also been interior damage to the ceiling and walls in the front door fover and the stair well too. Finally, the result of these ice dams and resulting melting has rotted out the doorframe and wall area for the rear basement exit area.

- Strip off existing shingles on problem area up to main box (Approx. 20' x 24')
- Pull off roof deck boards on stripped area of existing roof
- Add Prop-a-Vent over existing insulation/vent soffit
- Re-plywood the roof area from which boards were removed
- Install soffit vent at bottom edge of newly roofed area
- Install new ice and water shield and drip edge
- Install rubber roof on stripped portion
- Tie into existing shingles/existing skylight
- · Hard wire and install 2 ventilation fans on back of main roof
- Install a gutter and downspout
- Remove the rotted wood, waterproof the interior structure, and replace exterior wood with white PVC
